The State of Preservation of the Shakhty Rock Art Site and the Prospects of Its Conservation

This article deals with the preservation of the Shakhty rock art site, discovered in the Eastern Pamirs in 1958 by the leading Central Asian Stone Age researcher V.A. Ranov. The analysis of photographs taken in the Shakhty rock shelter during the 2019 survey revealed the nature of destructive processes at the site due to environmental conditions of the Eastern Pamir highland. The article integrates the results of analysis of Ranov's archives at the Donish Institute of History, Archaeology and Ethnography of the National Academy of Sciences, Republic of Tajikistan. Thanks to Ranov's diaries and photographs, it was possible in 2019 to assess the degree of erosion on the rock surface, and the loss of fragments of painted images over more than 60 years. Emergency areas requiring conservation efforts were identified. Principles of conservation and restoration of rock art are outlined, and an overview of techniques developed for sites of this type in the post-Soviet space in the last quarter of the 20th century is presented. State of the art conservation methods for rock art, which, in the futur

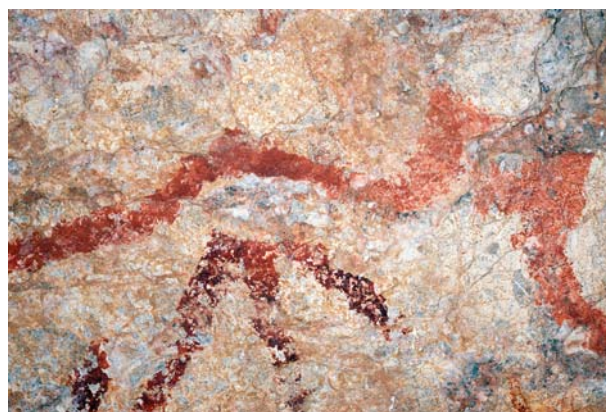
possibly representative of the bovid family (Bovinae), and an anthropomorphic character, disguised, according to the scientist, as a bird (Ranov, 1961: 71). Surveys of the recent years, using modern methods for detecting poorly distinguishable colored images, indicate the presence here of other images that are traced in half-erased lines (Zotkina, Abolonkova, Solodeynikov et al., 2020). Such preservation is explained by the intensity of scaly exfoliation of the rock—desquamation of limestone due to severe temperature changes, which is typical for the highland regions of the Pamirs. Ranov pointed out the loss of the rocky surface, including the surface with remnants of the pigment: “The wall of the shelter, on which the drawings were applied, is very uneven, rough and, as always in limestone, laminated; individual rough spots protrude above the surface of the rock by 7.5, 3, and 2 cm. There are almost no smooth surfaces” (1958: 29–30). According to the scholar, once, the entire plane of the wall, starting almost from the entrance of the shelter and ending with the narrowest point along the southern wall, was decorated with drawings. This is evidenced by numerous spots of paint, sometimes individual lines or the remains of figures, which are no longer decipherable. Ranov noted that destructive processes continued, as was evidenced by fragments of images with scales fallen out (Ibid.). The results of the 2019 survey also record many losses of the rock surface due to desquamation (Zotkina, Bobomulloev, Solodeinikov et al., 2022: 63). Careful examination of the images reveals areas with paint applied over the previously lost fragments of the surface (Fig. 2). This may indicate, on the one hand, that the process of destruction of the wall with drawings began long before they were created, and, on the other hand, that the images were renewed. The significant traces of the rocky surface loss can also be observed on the painted lines (Fig. 3).

Fig. 3. Fragment of a zoomorphic image with traces of desquamation over the paint layer (after (Zotkina, Bobomulloev, Solodeinikov et al., 2022: Fig. 2, 3a), fragment).

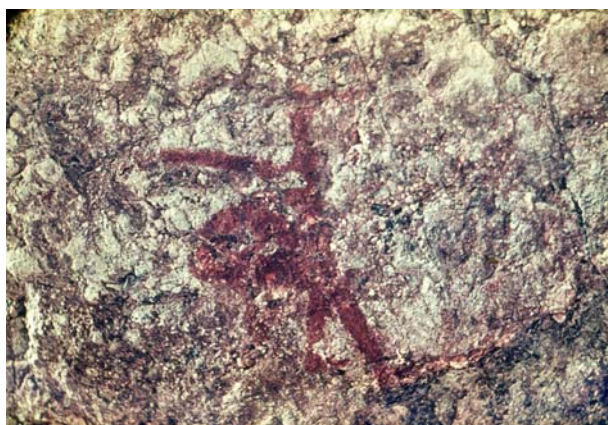
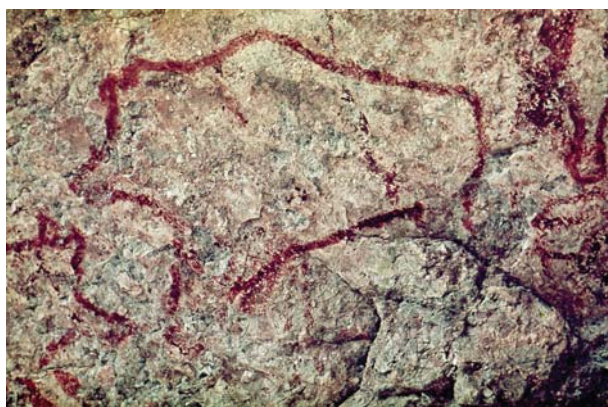
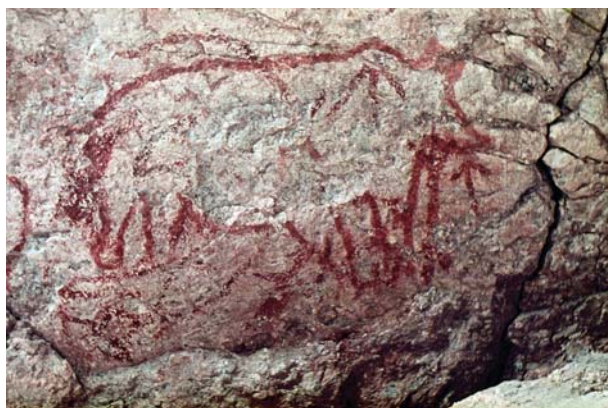
The main object of analysis were the photographs of individual images taken in 1958 (Fig. 4). When

Fig. 4. Photographs of images in the Shakhty rock shelter. Photo by V.A. Ranov, 1958 (slides from the funds of the IIAE NAN RT).

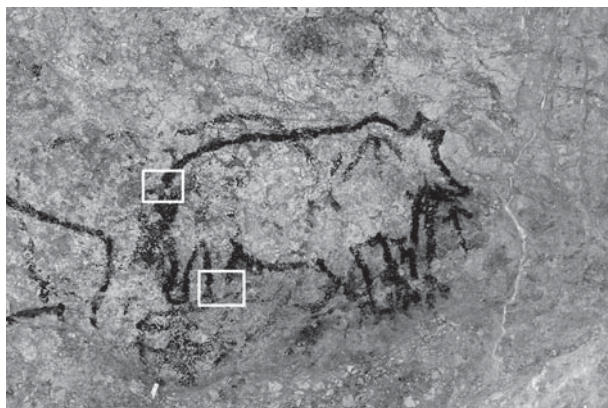
Fig. 8. Pigment map of the photograph of 2019: areas with traces of paint loss that occurred between 1958 and 2019.

show the slight loss of the rock surface with paint layer on another animal image (Fig. 7, 8). Obviously, this section of the rock surface requires conservation to slow down the destruction process.

The damaged section of the plane with paint can be reinforced using the direct methods of conservation only. Depending on the features of the rock crust subject to destruction, effective methods can include structural strengthening of the rock and flanging. Structural strengthening of the rock is used in cases when the inter-crystalline bonds of the rock are breaking down. Another form of destruction is longitudinal delamination, when layers of different hardness alternate in the stone. Destructive processes of this type are among the most dangerous. Structural strengthening of the rock is carried out in two ways: by steeping, when a special solution is repeatedly applied using a flat brush; and by injection, i.e. the introduction of a stone hardener directly into the cracks. After these procedures, the strength of the stone structure is checked. The final result can be judged after a month of exposure under natural conditions (Shchigorets, Vlasov, 2018: 47). As materials for strengthening, some experts recommend the use of helium ethers of silicic acid, for example, stone strengtheners from Remmers. They easily penetrate into the depths of the stone, where they turn into a gel-like substance (Ibid.). However, the most promising today, in our opinion, are preparations of the CaLoSiL series of the German company IBZ-Salzchemie GmbH & Co.KG, which contain calcium hydroxide $\text{Ca}(\text{OH})_2$ nanoparticles suspended in various alcohols (ethanol, propanol, isopropanol). The average particle size is 150 nm. These preparations act like consolidators and

In some cases, associated with a significant delamination of the rock crust from the massif, it is possible to use the reversible flanging method developed by the specialists from GosNIIR. It consists in fixing such a crust with a finishing mixture along the edge, without filling the voids formed under it. This technique practically does not affect the moisture- and vapor-exchange between the atmosphere and the inner layers of the rock (Ageeva, Rebrikova, Kochanovich, 2004). The composition of the restoration material varies depending on the type of stone, and it is based on polymeric organosilicon binders (MSN-7, K-15/3, KO-08) (Ageeva, 2003: 54–61).
