I.V. Balyunov

*Tobolsk Historical and Architectural Museum-Reserve,
Krasnaya pl. 1, bldg. 4, Tobolsk, 626152, Russia
E-mail: balyunoff@mail.ru*

Architectural and Archaeological Studies in the Tobolsk Kremlin During the 1950s (Based on Photographic Documents at the Tobolsk Museum-Reserve)

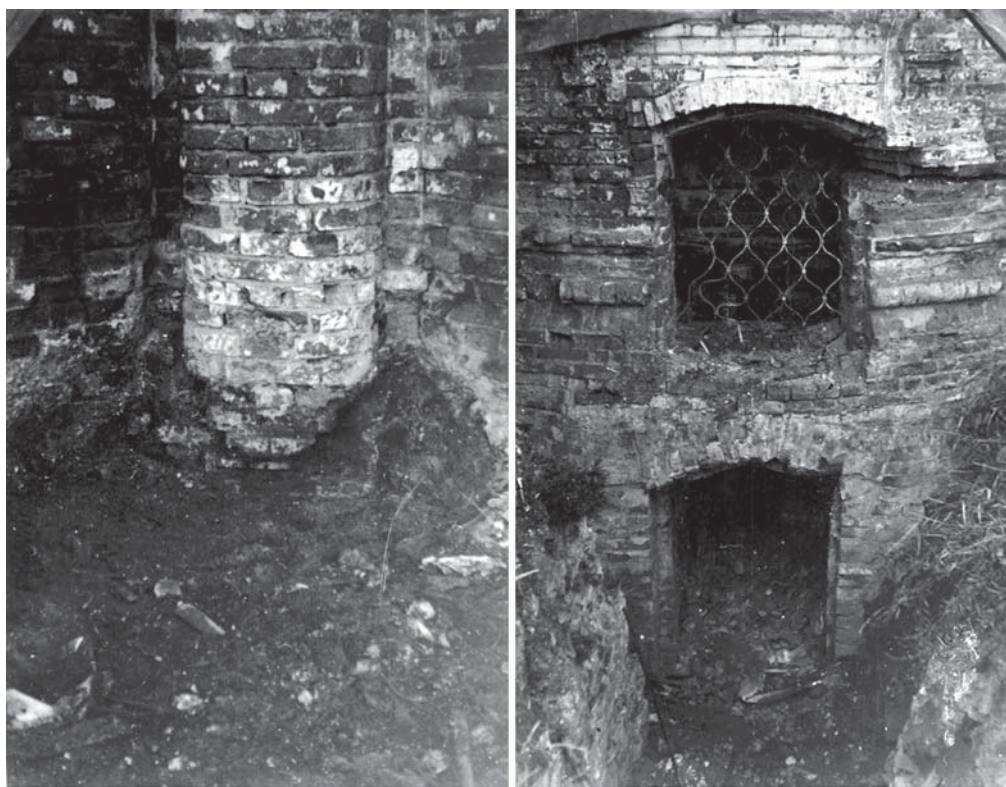
Fig. 3. Unearthed foundations of the apse of St. Sophia-Dormition Cathedral. View from the east (TM-15849 / 35).

awaiting restoration. For example, the building of the Gostiny Dvor, St. Sophia Cathedral, the Bishop's stables, and the supporting walls of the Pryamsky Driveway were investigated in this manner. One can get some idea of these works from the photographs showing the exposed sections of stonework in the apses of St. Sophia Cathedral (Fig. 3). One exception included some test pits made along the eastern part of the fortress wall, where tremendous work was carried out to identify the lost objects.

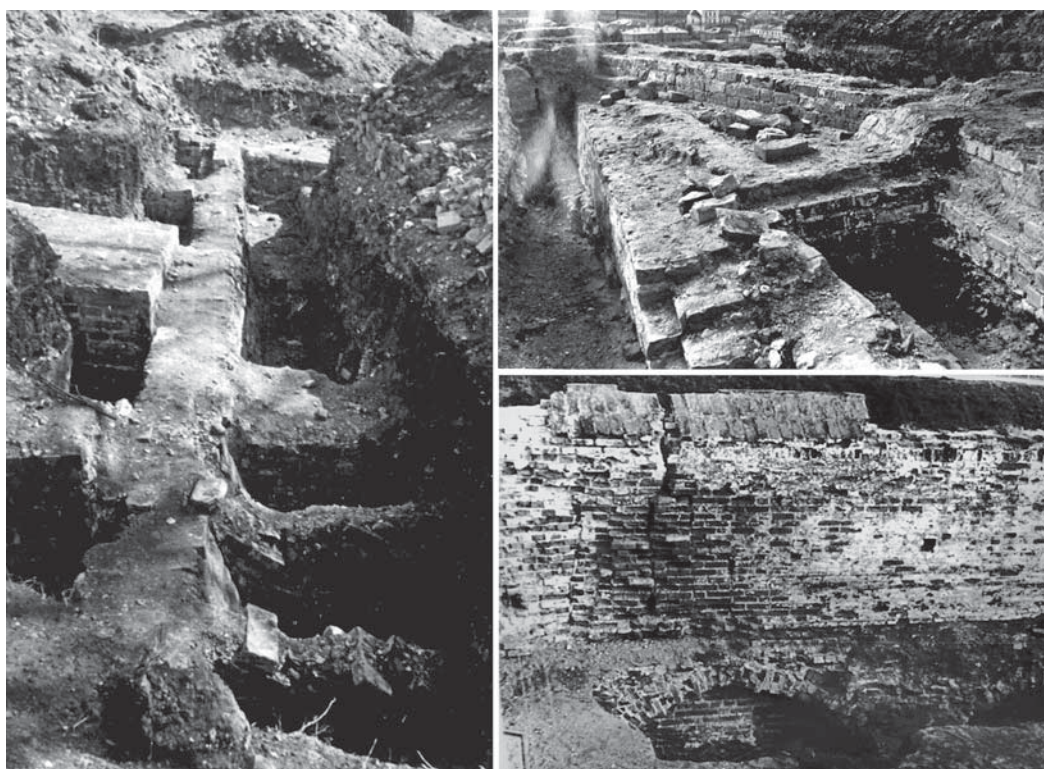
Fig. 9. Unearthed foundations of the fortress walls (TM-15849 / 44; NV-4282 / 13).
